MATRIX		Service Bulletin Matrix T7xe/7xe consoles troubleshooting	
Effective Date: June. 12, 2015	Models Affected: HURESAC-7XE-04-C (EP613) T-7XE-04-C (TM520)	Bulletin Num. NB-1507008 Ver.6	
Prepared by: Eric Chen

Troubleshooting for 7xe console. Tables are organized by symptoms:

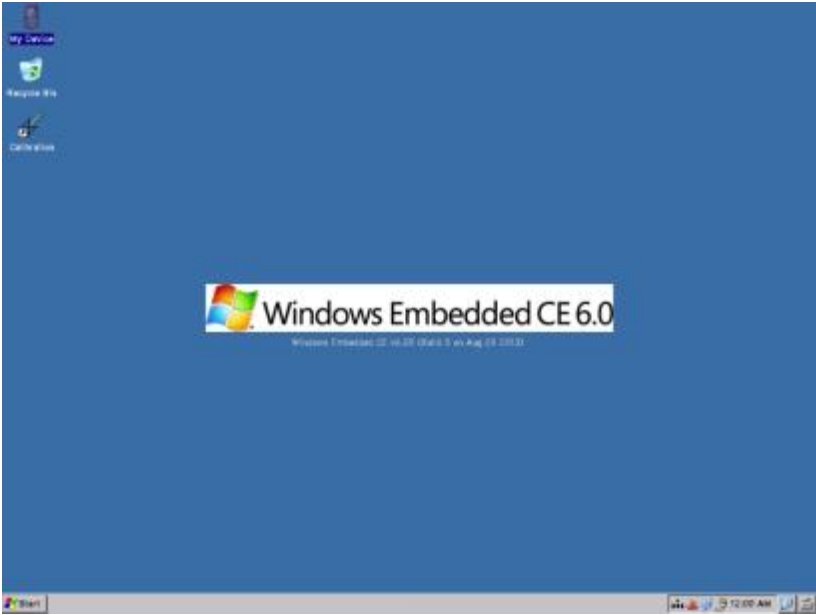
Case 1: WIN CE screen

- 1. T7xe/7xe Console shows WIN CE mode when turn on machine.

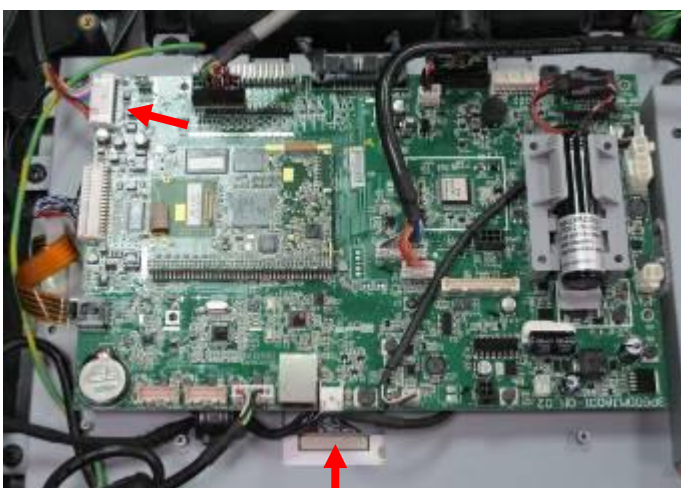
Solution 1- Check LVDS wire

Console has unusual color display or fuzzy screen as below picture.

1. Remove UCB.
2. Check the LVDS wire connection on the LCD and the UCB. Unplug both sides and plug them in again.

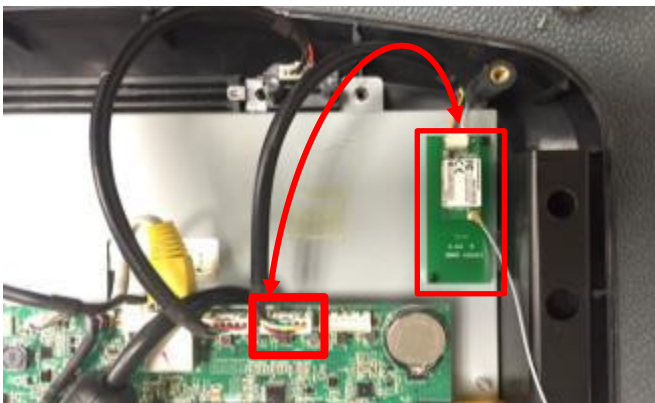
Solution 1- Replace Wifi board

Console touch panel no reaction, keypad no function (without beep sound when press)

1. The touch screen has no reaction and keypad has no "beep" sound when press.
2. Please try to disconnect Wifi board and cycle power.
3. If console works fine after wifi board is disconnected, replace Wifi board.

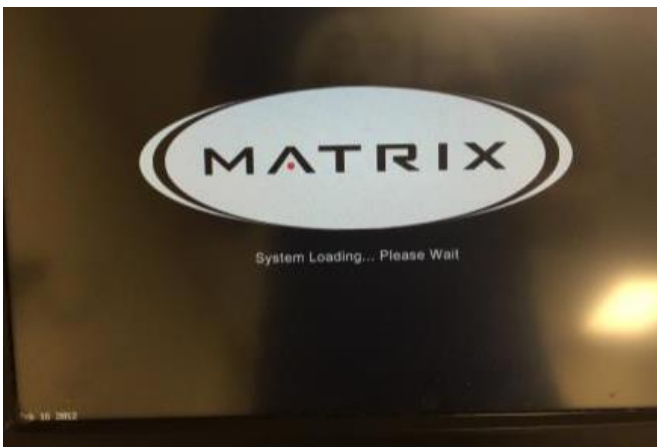
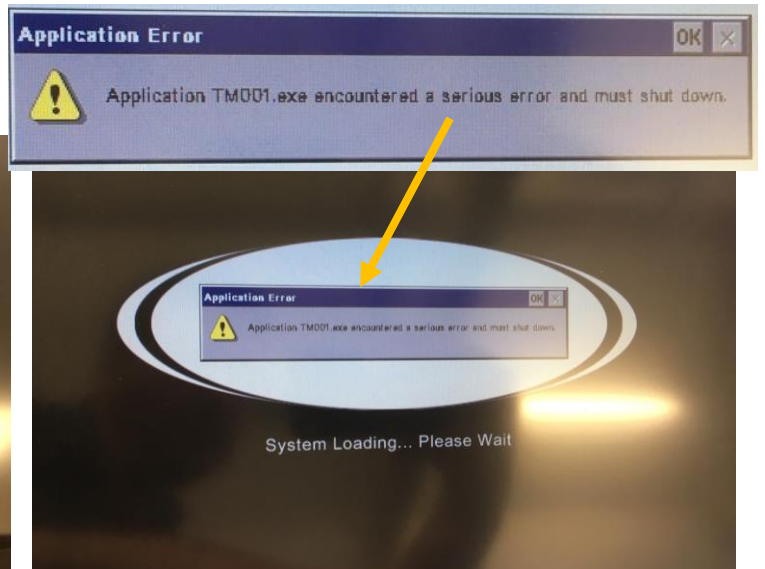
Case 6: Matrix loading screen

Console shows "Matrix system loading" or "Matrix Application Error" and can't access to "Go" screen.

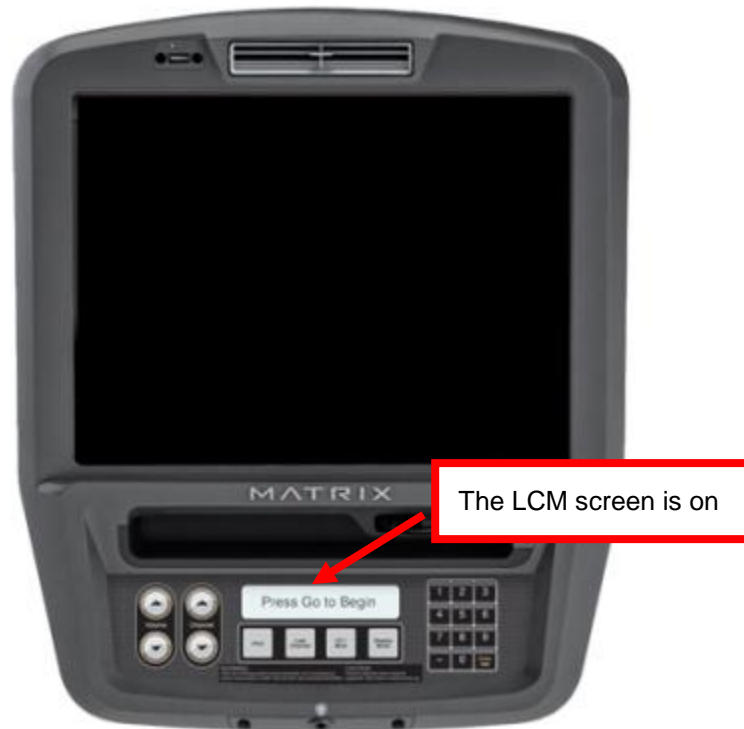
Case 8: Blank screen

Console shows blank screen, but LCM (Low display) is on.

Check the LVDS wire connection on the UCB and TFT panel. Replace the LVDS wire if it's damaged. If the issue persists, please continue with solution 2.

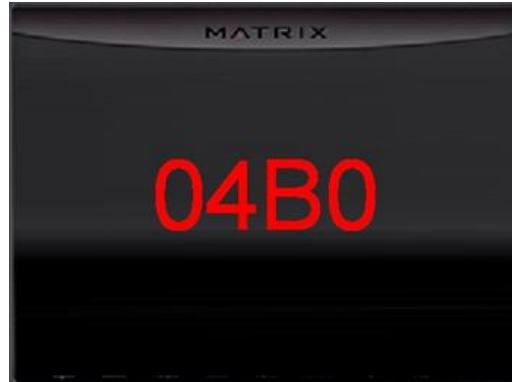
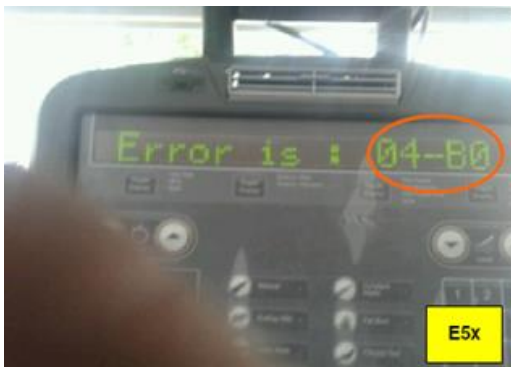
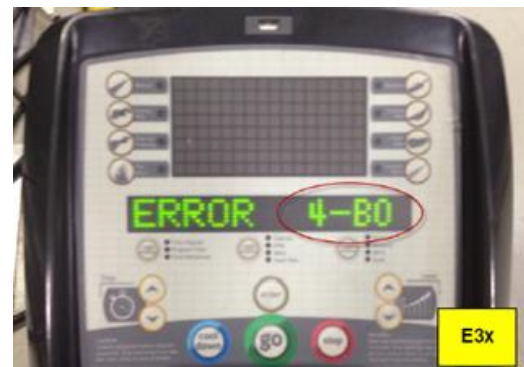
Case 9: Low Battery / 04B0

Console is showing pedal faster, low battery then 04B0 error code (only happen with self-power mode).

1. Check the connection of the console communication cable on console and the MCB.
2. This is a software data loss issue of LCB1. Require upgrade LCB software or replace LCB. Please refer to NB-1311006.

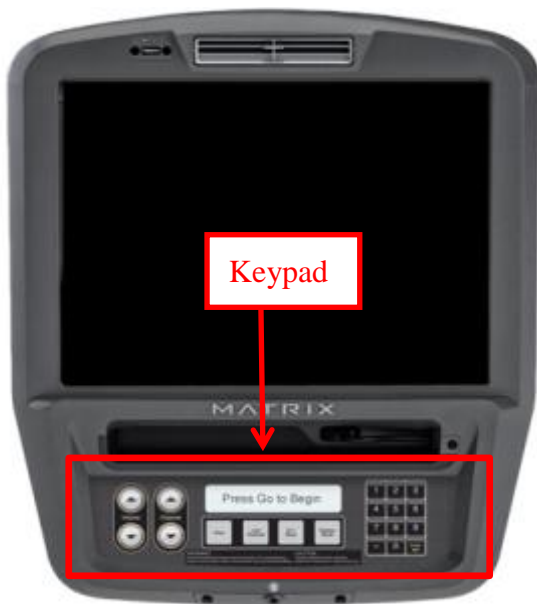
Case 10: Keypad / Quick key

Keypad or Quick Key no reaction.

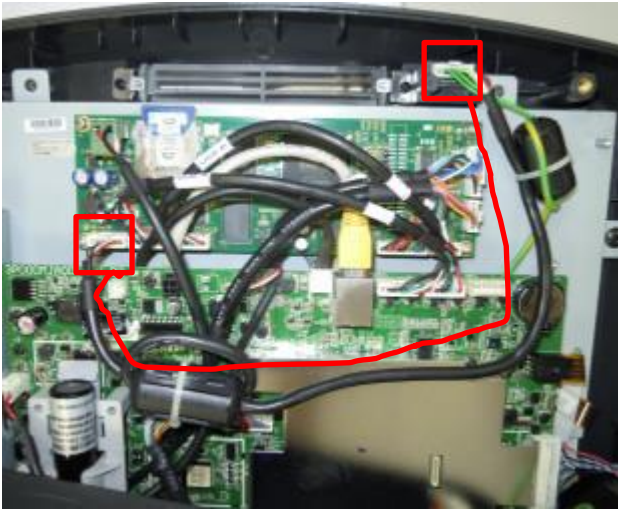
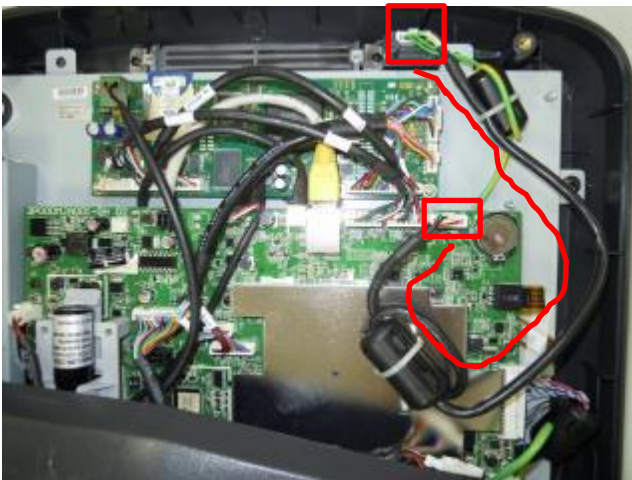
Solution 2- Check VA board- continued

P.S. The purpose is by- pass the failure VA board. If the VA is damaged, replace it if necessary.

4. Please un-plug the USB cable from VA board.
5. Plug in the USB cable to Console control board directly. Re-boot the machine to start software upgrade process.
