MATRIX		Service Bulletin Matrix T7xe/7xe consoles troubleshooting	
Effective Date: June. 12, 2015	Models Affected: HURESAC-7XE-04-C (EP613) T-7XE-04-C (TM520)	Bulletin Num. NB-1507008 Ver.6	
Prepared by: Eric Chen

Troubleshooting for 7xe console. Tables are organized by symptoms:

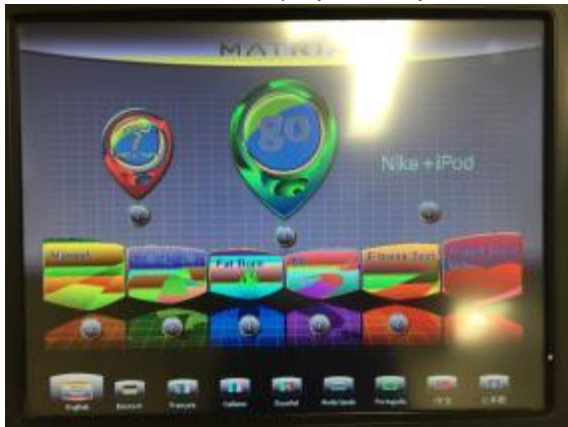
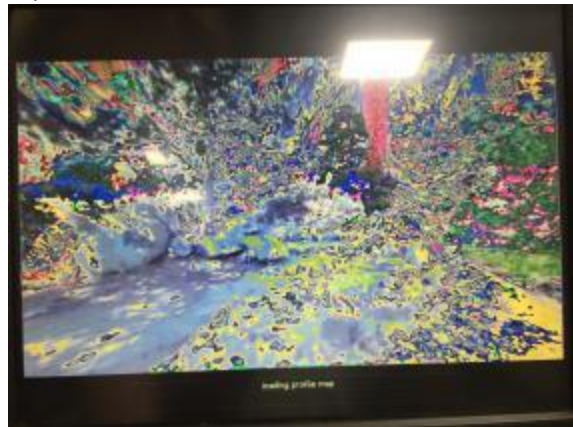
Case 3: Display fuzzy or wrong color

Console has unusual color display or fuzzy screen as below picture.

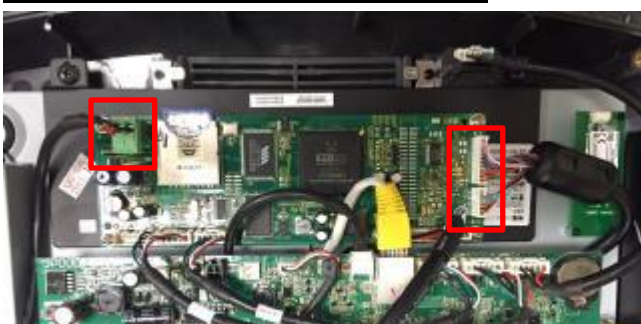
Solution 1- Check wire connection

VA is not working.

Check the connection from the VA board to UCB.

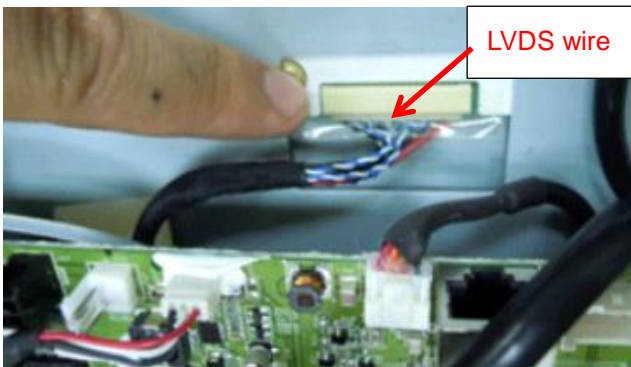
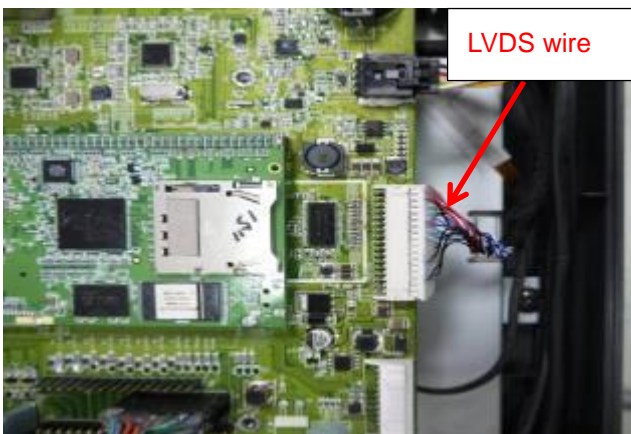
Solution 1- Check LVDS wire

Case 8: Blank screen

Console shows blank screen, but LCM (Low display) is on.

Check the LVDS wire connection on the UCB and TFT panel. Replace the LVDS wire if it's damaged. If the issue persists, please continue with solution 2.

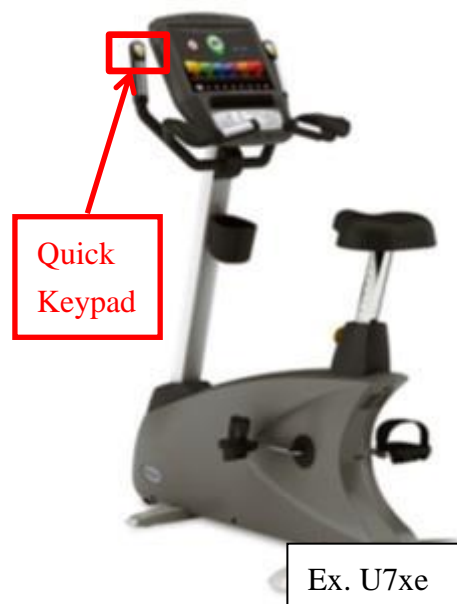
Case 10: Keypad / Quick key

Keypad or Quick Key no reaction.

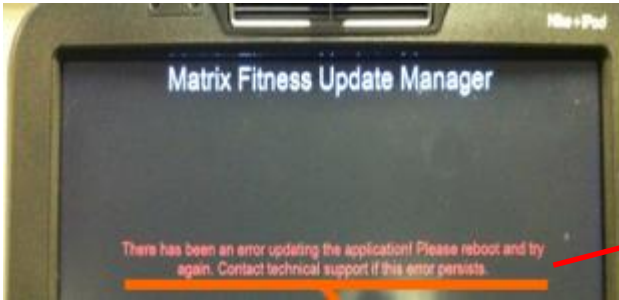
Case 11: S/W upgrade error remind

During software update, console shows error message as below.

There has been an error updating the application! Please reboot and try again. Contact technical support if this error persists.

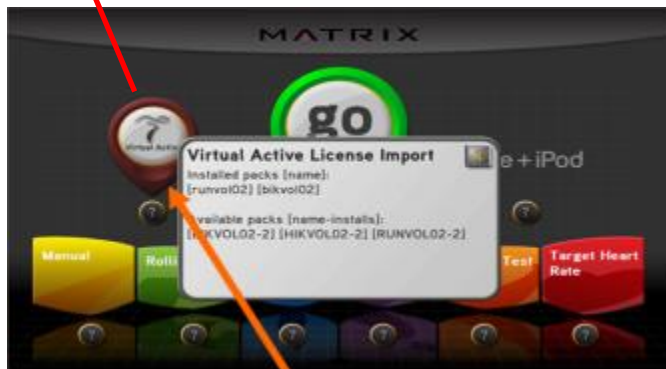
Solution 1- Check VA board

(Reason: Grey VA icon results in this issue.)

If VA is installed on the console, wait until the Virtual Active icon on the standard display picture turns red prior to updating the software.

If this console is installed with VA board, please wait VA icon to become red.

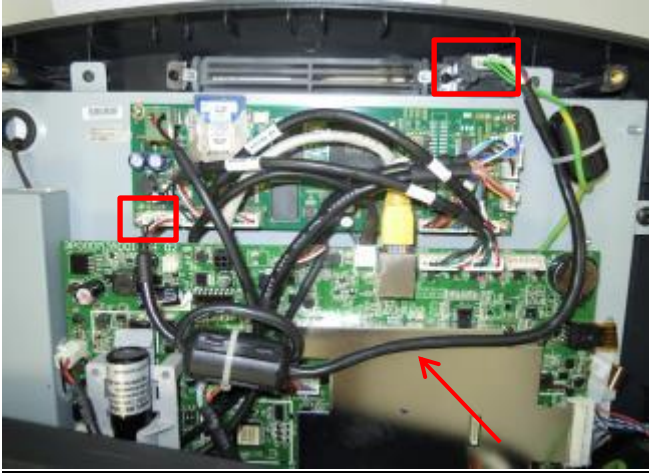
Solution 1- Check wire connection

When plug in USB to upgrade SW, the console cannot auto run install process.

Check the USB wire connection and replace it if necessary.

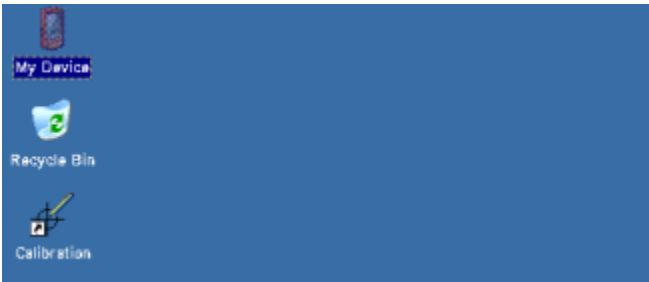
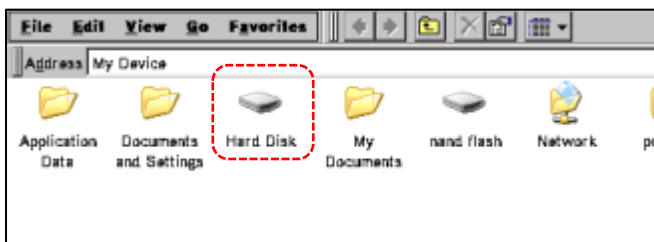
Solution 2- Check VA board

1. This situation will happen on T7xe/7xe with VA board.
2. Press "enter 4006 enter" four times to enter WIN CE mode.
3. Select "My Device." If there is no "Hard Disc", go to step 4.
Notice: To identify this issue, please plug in the USB after enter WIN CE mode-

4. Please un-plug the USB cable from VA board.
5. Plug in the USB cable to Console control board directly. Re-boot the machine to start software upgrade process.

P.S. The purpose is by- pass the failure VA board. If the VA is damaged, replace it if necessary.

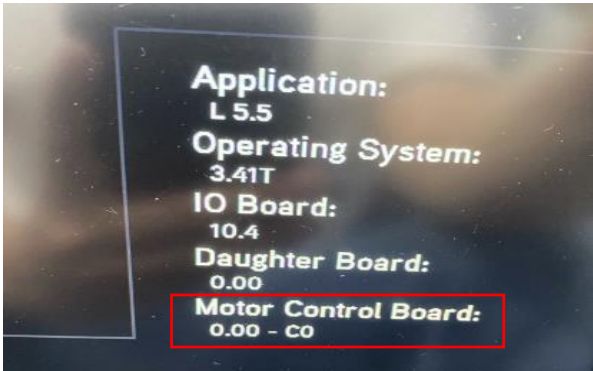
MCB type C7 does not support the Tread Sense function on the Win CE (LMM) console

MCB Type / Software	Tread Sense Function	Pic
C7(current production) <u>0.00 – C0</u>	No

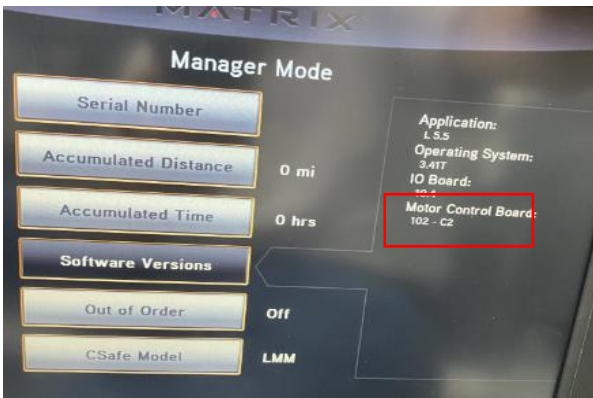
C2 (Win CE only) <u>102-C2</u>	Yes

Modify the MCB type from C7 to C2, so the C2 can support the WIN CE (LMM) console with Tread Sense function.

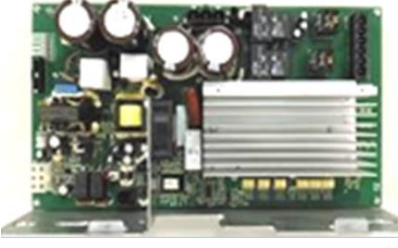
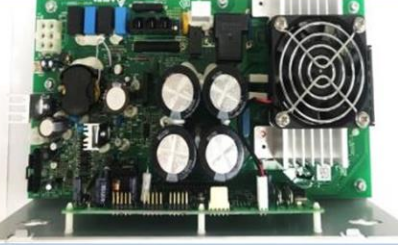
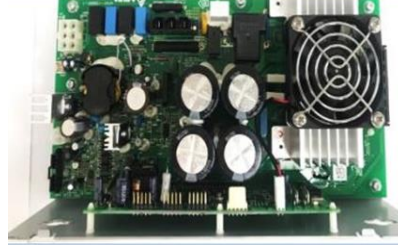
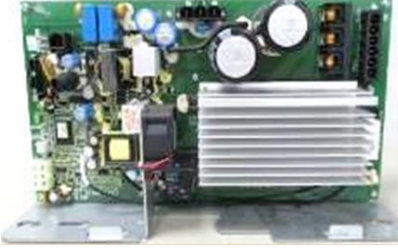
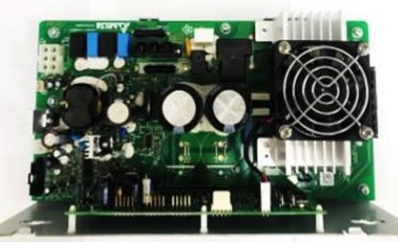
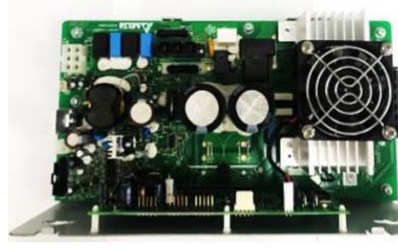
Table -2. Below picture of difference between old and new MCB

OLD ~ 2018/9/24	NEW Type C7 2018/11/23 ~ (Current Production)	NEW Type C2 2020/09/01 ~ (Only for Win CE console)
110V	0000094477 (S/W – v006)	1000435058 (S/W – v106)	1000457109 (S/W – v102)
