<h1>A30/A50</h1> <h2>Service manual</h2>
--

Matrix Retail A30

Matrix Retail A50

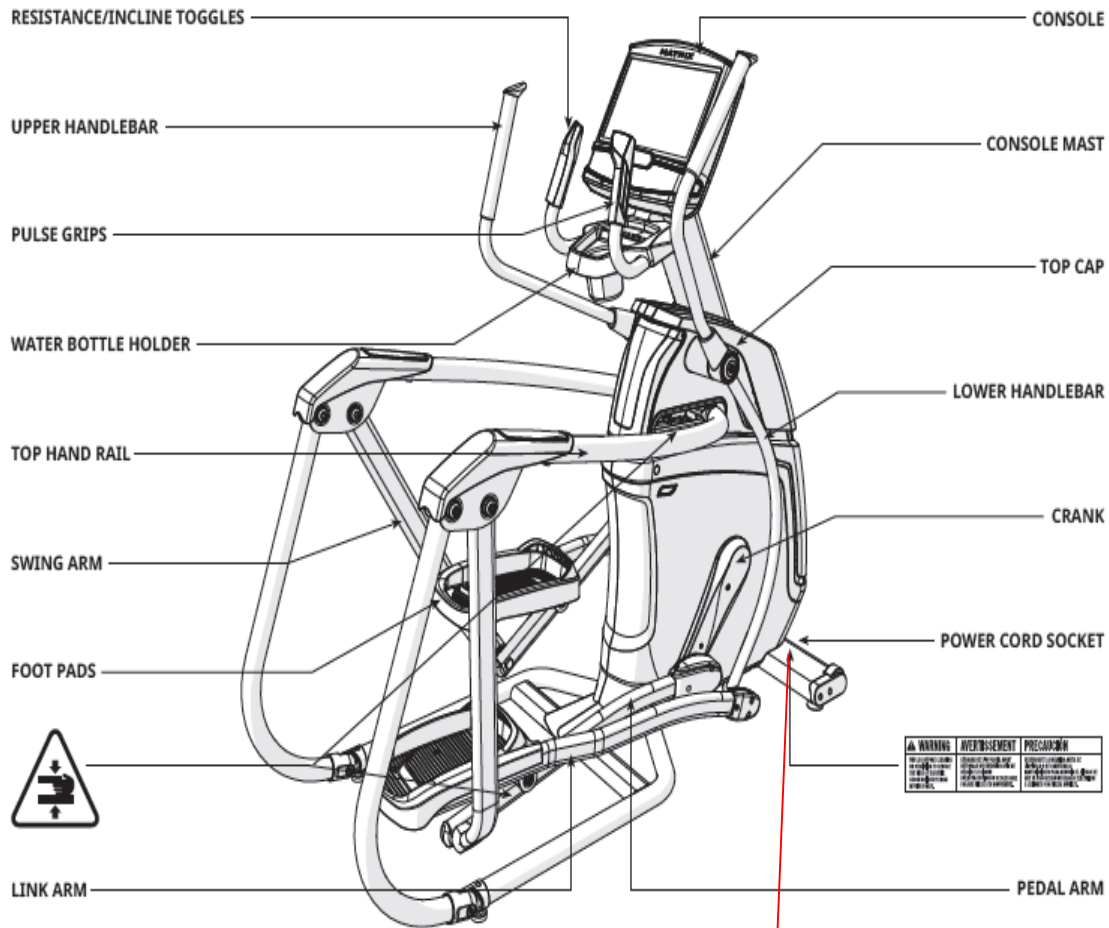
MATRIX A30 ELLIPTICAL FRAME

EP701-1US-F 10706987
MODEL:A-30-02-F
S/N :EP7011601CX00001
MADE IN CHINA

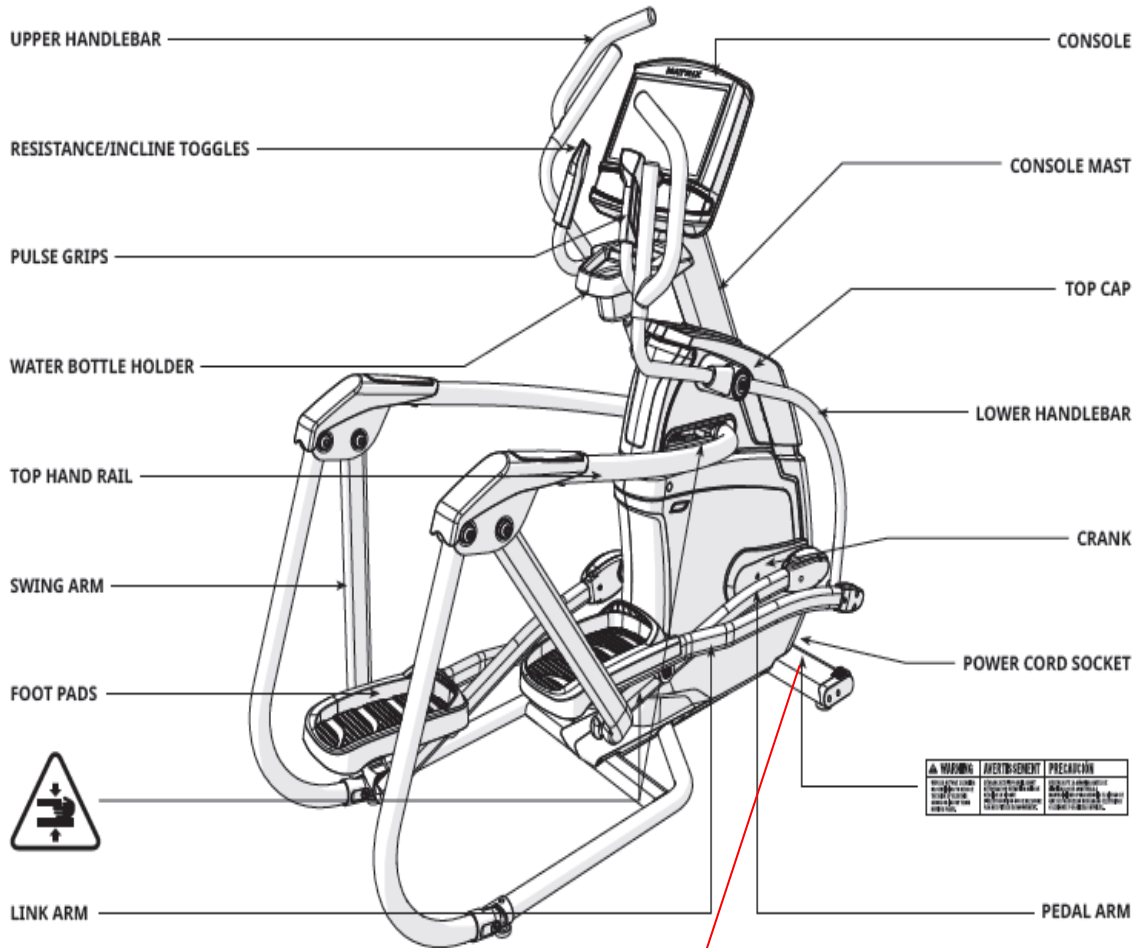
MATRIX A50 ELLIPTICAL FRAME

EP702-1US-F 10706988
MODEL:A-50-F
S/N :EP7021601CX00001
MADE IN CHINA

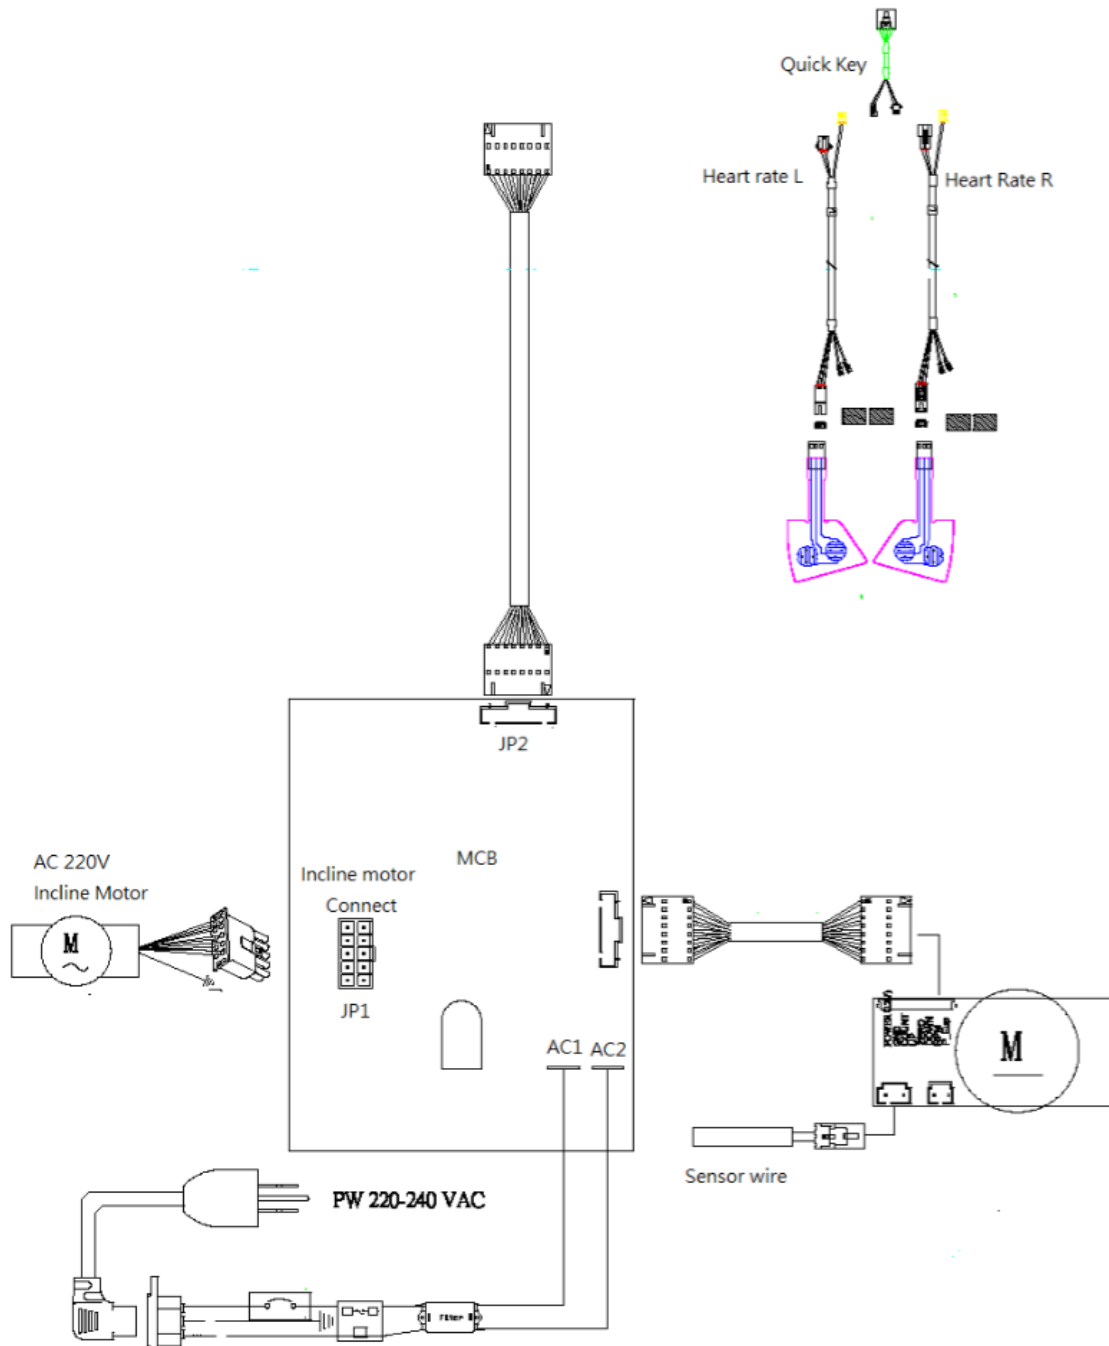
3.1 ELECTRICAL DIAGRAM

A30

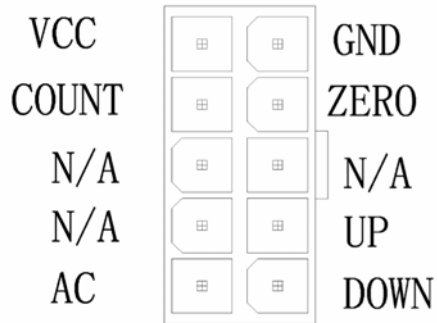
A30/50 Connection

Incline Motor CONNECT

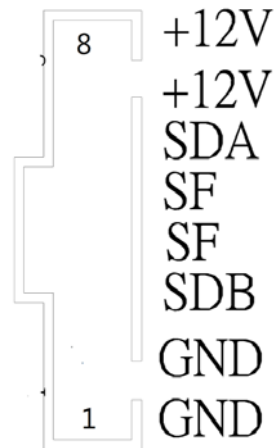
Console Connection

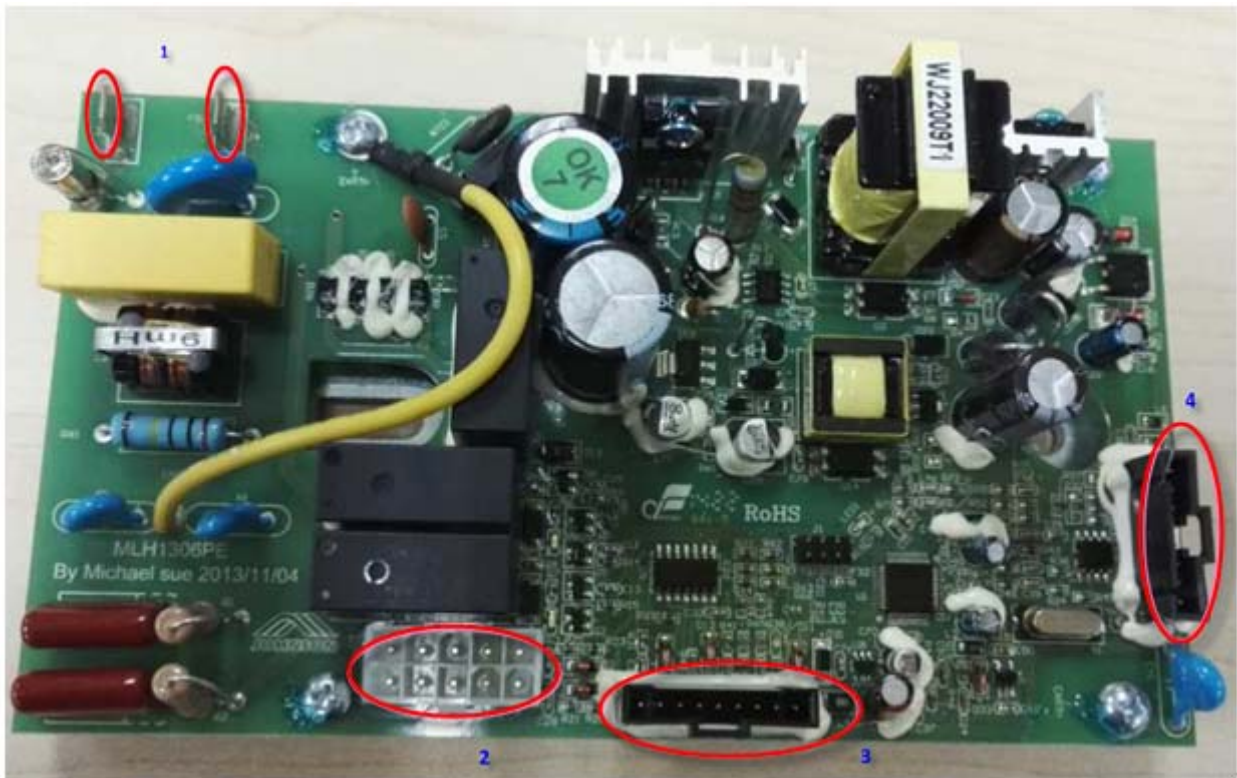
A30 MCB

1	AC input connector
2	Incline connector
3	ECB connector
4	Console connector

Number of LED Blinks	Status	Description	Possible Problem Component
1	Works normally	Works normally	
2	Optical Encoder without feedback	The optical encoder is without feedback for 3 seconds during start procedure or 1 second during workout	Poor contact or damage to the optical encoder
6	The incline motor is stuck or has lost efficiency	There is no signal to the MCB when the incline motor is energized.	Incline Motor
7	Communication abnormal	No or abnormal communication between the console and LCB.	Console Cable, UCB, or LCB

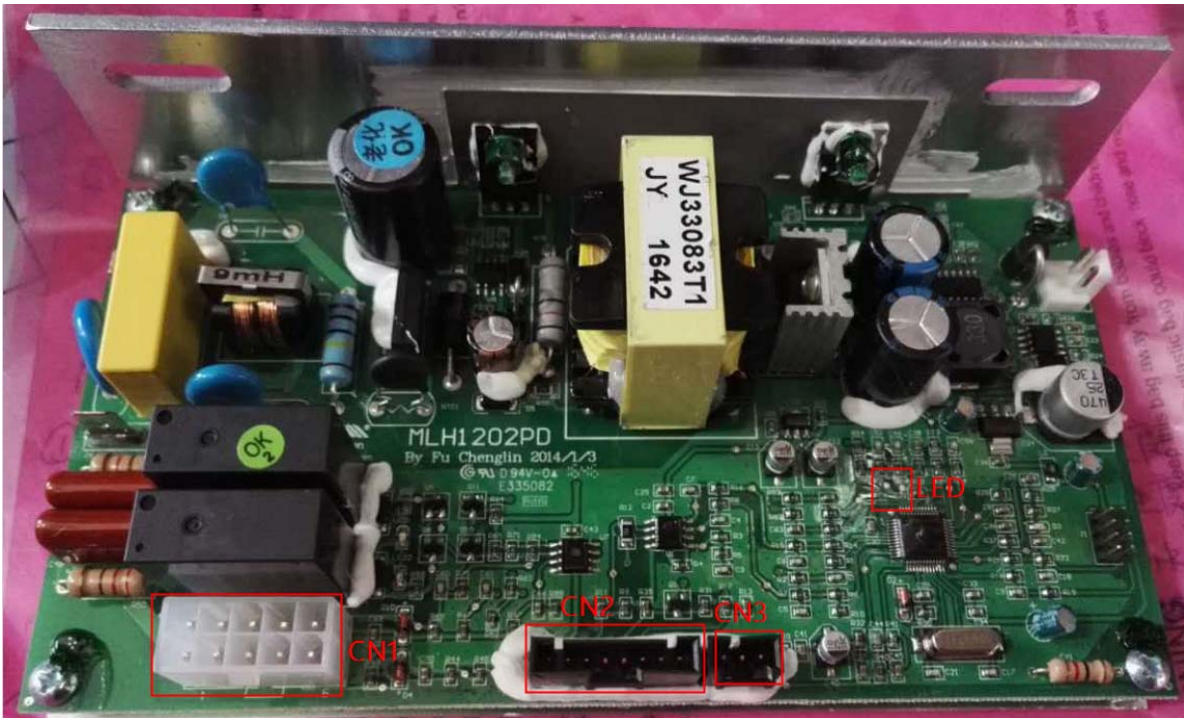
A50 MCB

CN1	Incline Motor Connector
CN2	Console Connector
CN3	RPM feedback wire connector

Number of LED Blinks	Status	Description	Possible Problem Component
1	Works normally	Works normally	
3	overload/overcurrent	The motor current is over rated for more than 4 seconds.	
7	Communication abnormal	No or abnormal communication between the console and LCB.	Console Cable, UCB, or LCB

1. Check the power resistor wire connection between the power resistor and LCB (fig-1)
2. Check the Connection wire between consoles to LCB. Try to plug off and plug on connector (Page 13 ,CN2)
3. Check the power resistor whether 10K Ω by multi-meter (Fig-2), if not, replace power resistor.
4. If yes, Replace. LCB.

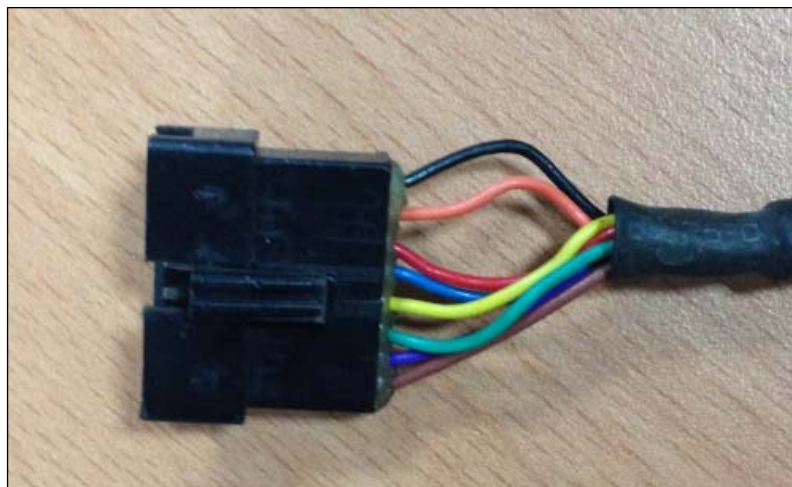
FIGURE A
(Console cable's connectors with UCB)

1. Check the connection of the console cable at the console. Unplug the console cable from console, and use a multi-meter to check the voltage through the console cable. Normally it should be 12VDC between pin1 & pin8. If no voltage is present, the console cable or LCB is defective. Test voltage at LCB, if voltage is present replace console. If not, replace LCB.
2. If the voltage through the console cable is 12VDC, the console is defective. Replace it.

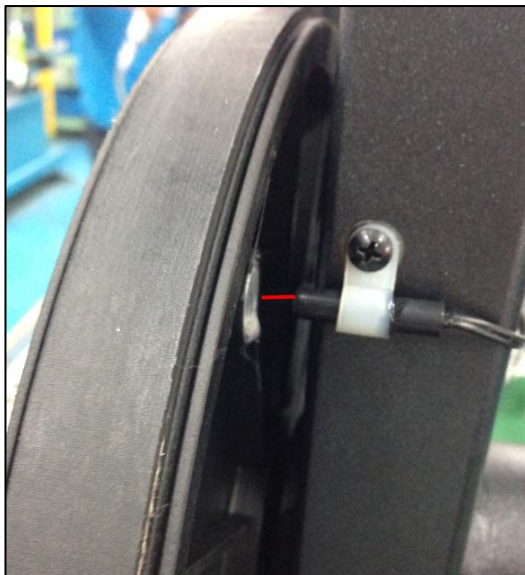
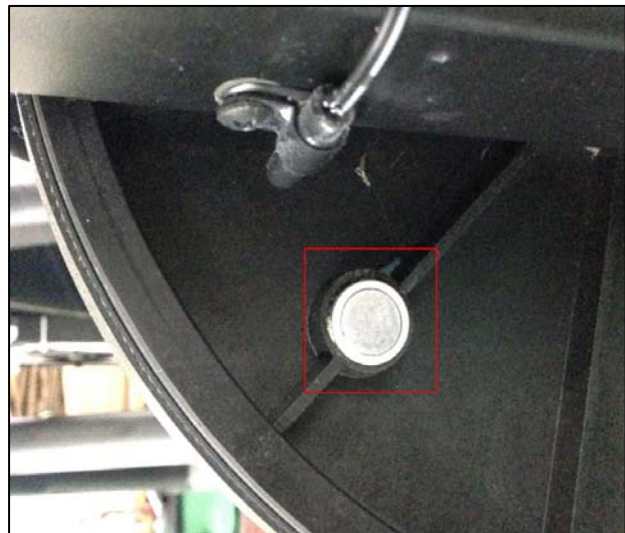
1. Bad connection between the console cable and the console: re-connect the console wire.
2. Speed sensor wire defective: Check the gap between the speed sensor and magnet on pulley. It is normal within 5mm (Fig A). Adjust the gap if it is too large. Test sensor with Ohm meter with pin1 and pin2, pass magnet by sensor to test.
3. Lost magnet of pulley: Re-install a new magnet (Fig. B).
4. Console defective: Replace the console set.

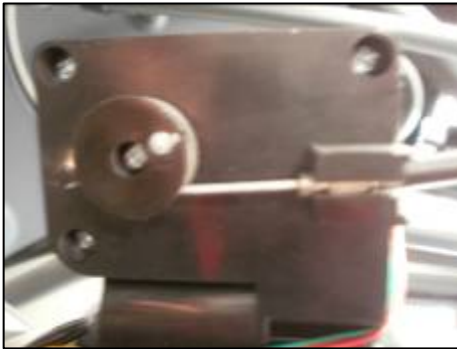
In resistance level 1, the head of steel rope directs to top right side (around 45 degree).

If the head of steel rope points to bottom left side, the resistance will be reverse. Adjust the head of steel rope to the correct position.

Notes: in the highest resistance level, the cable should have no tension (see ECB motor replacement section).

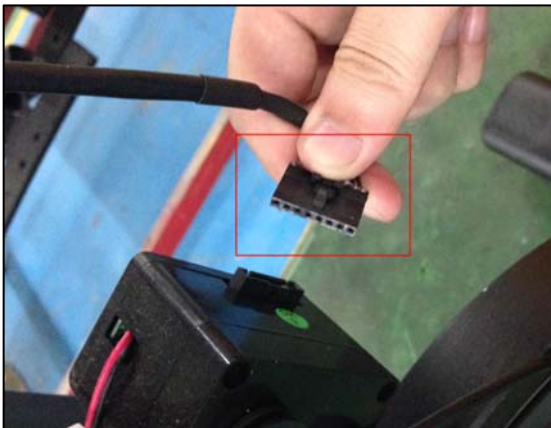
A) If ECB motor cannot move, the resistance will not be changed. The ECB motor or console cable is defective. Check the console cable inserted in ECB motor. Re-connect the console cable first, if still not working, test cable for damage. If tests good, replace the ECB motor, make sure both cable ends are seated properly.

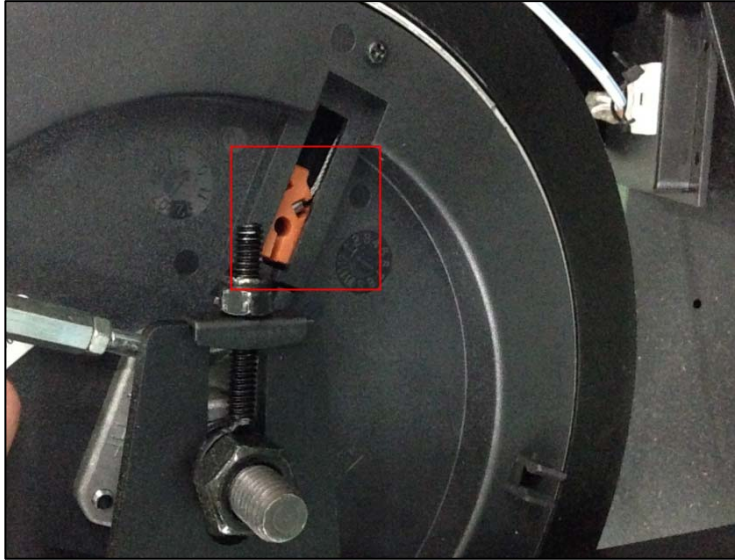
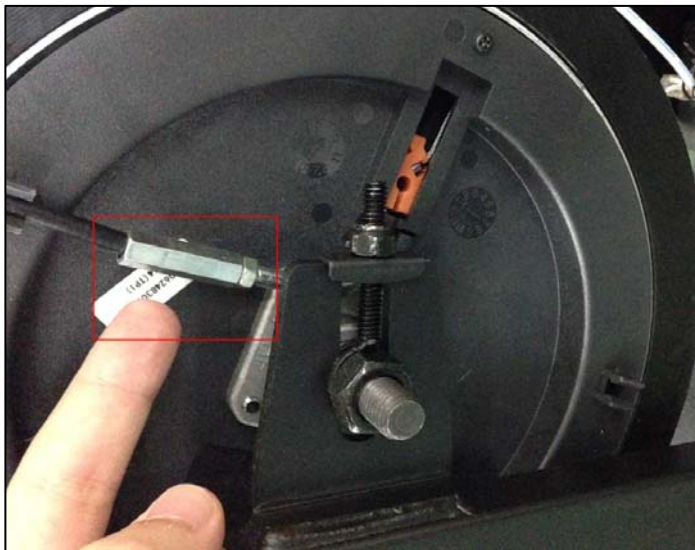
B) If the ECB motor can move, the resistance can be adjusted. If the resistance is still too heavy, check the gap between orange block and the bottom. It should be within 1-2 mm.

If the gap is larger than 1-2 mm, the resistance will be heavier than normal. Adjust the cable to the correct gap range.

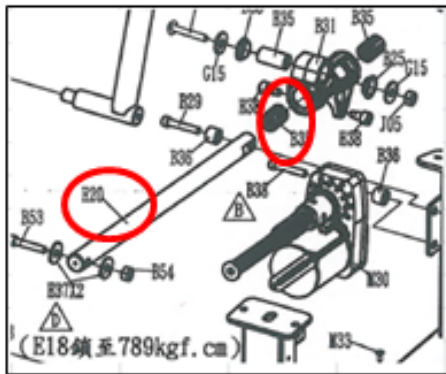
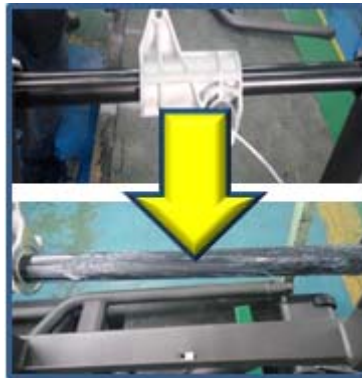
-If the noise is present only during incline, check to make sure the Teflon washers are installed at the incline motor connection point.

-Lubricate the guide rod of the incline motor with grease to reduce the abrasion with washer

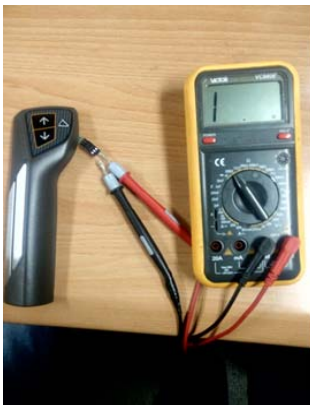
Pic1

a. When handlebar key does not work, firstly measure the pins with AVO meter to check if the keypad is bad.

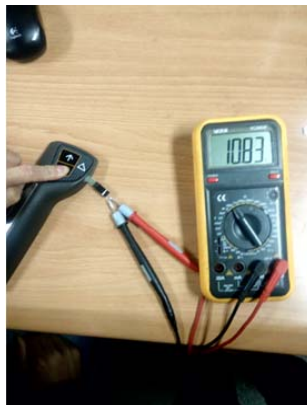
Pic2

b. Measure the resistance of keypad: "Ω" position on AVO meter, press keypad— keypad is good if the value <200Ω.

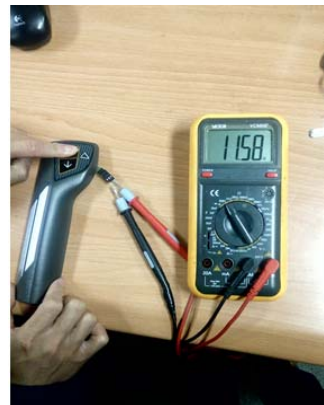
Pic3

c. Same as step2, measure the other side keypad. Pic3.

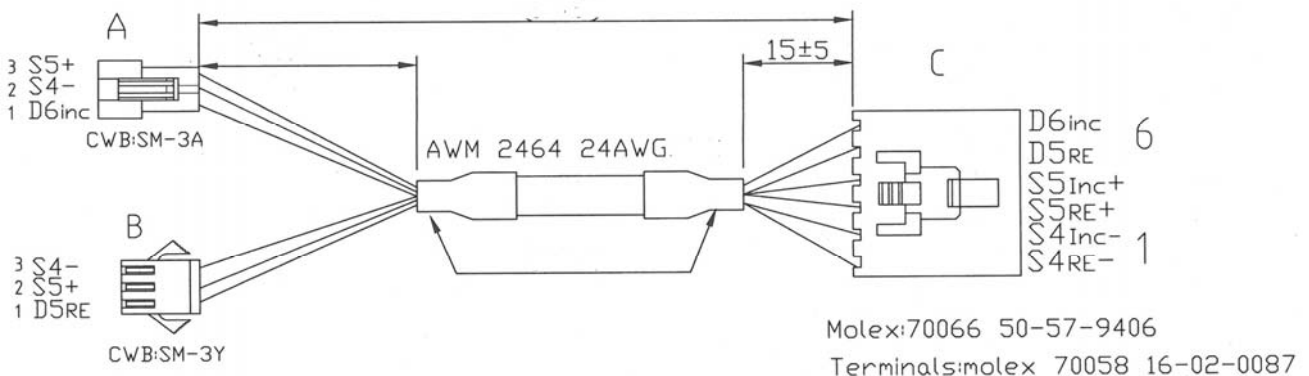
Note: A30/A50 Quick-key wire connection

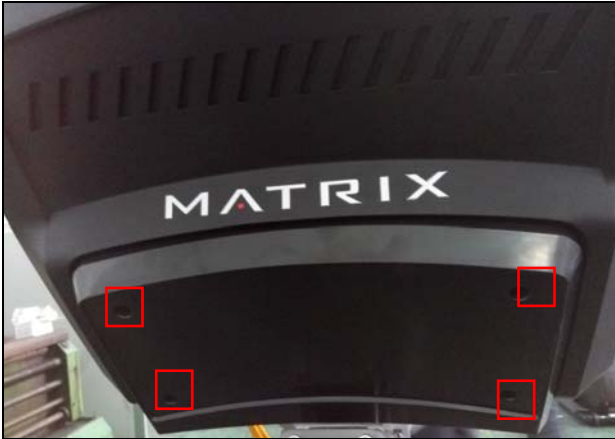
FIGURE A

- 1) Remove the 4 screws holding the console back cover to the frame (Figure A).
- 2) Remove the 4 screws holding the Console to the frame (Figure B).
- 3) Disconnect all connections from the console and remove the console from console mast. (Figure C)

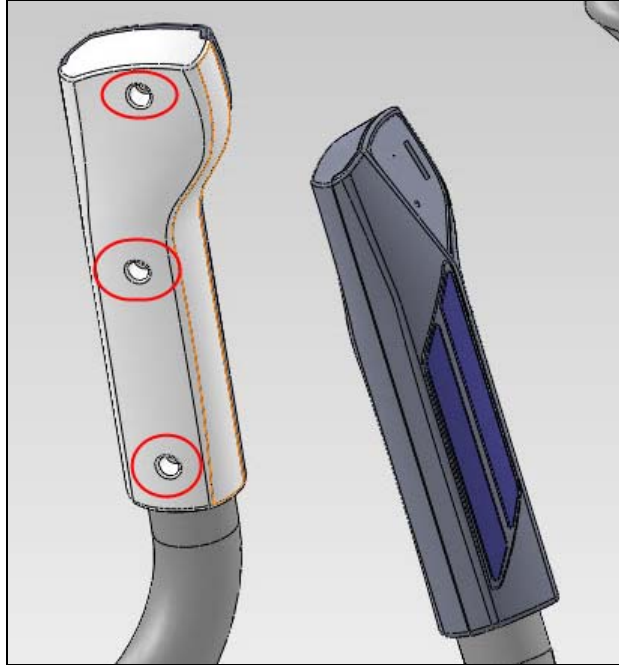
1. Remove 3 screws from the heart rate grip.

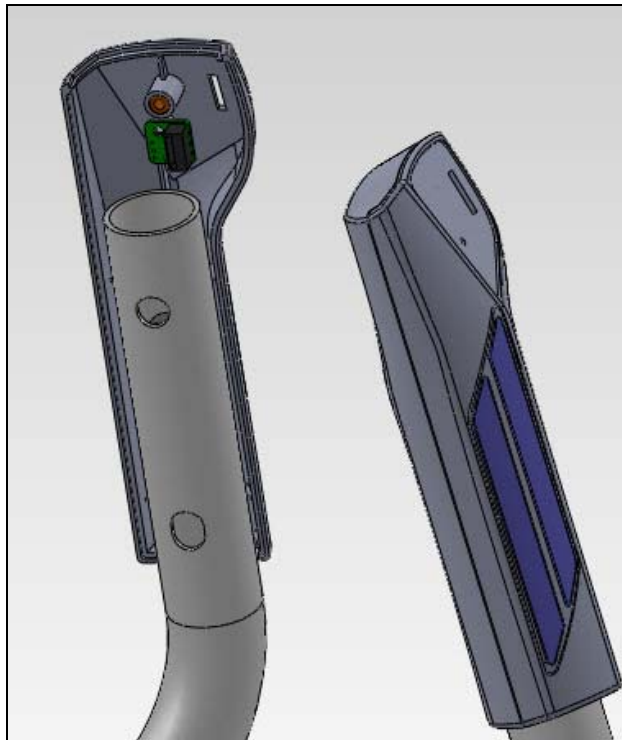
2. Separate the covers and disconnect all wires.

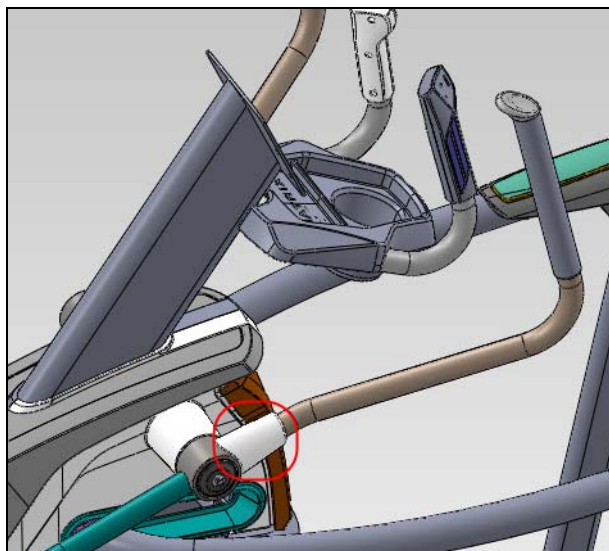
Figure A

1. Lift up on the cap by handlebar pivot joint (Figure A)

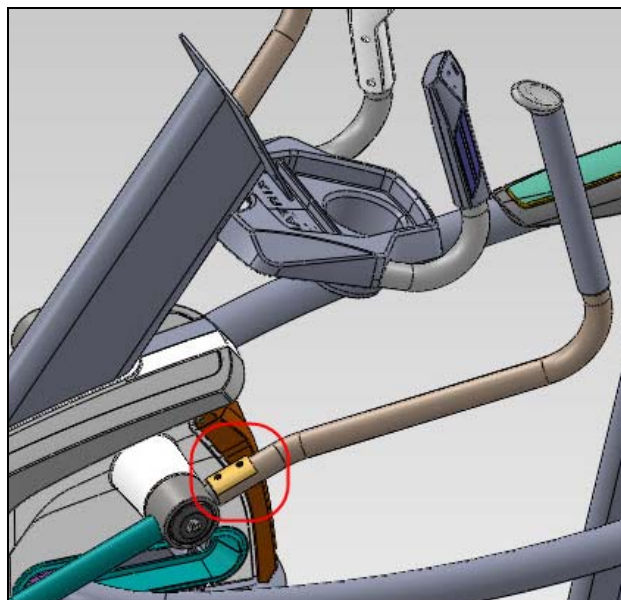
Figure B

2. Loosen the two sets screws, then you can pull the handle bar out of pivot joint.(Figure B)

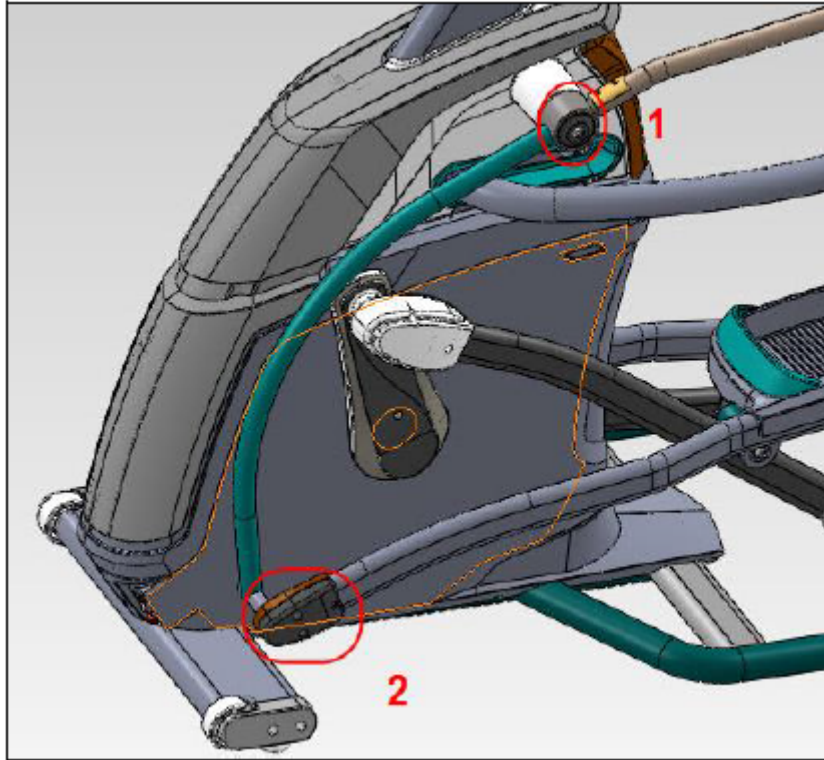
Figure A

1. Remove bolt from the pivot joint which is marked "1", and remove the cap marked "2" (Figure A)

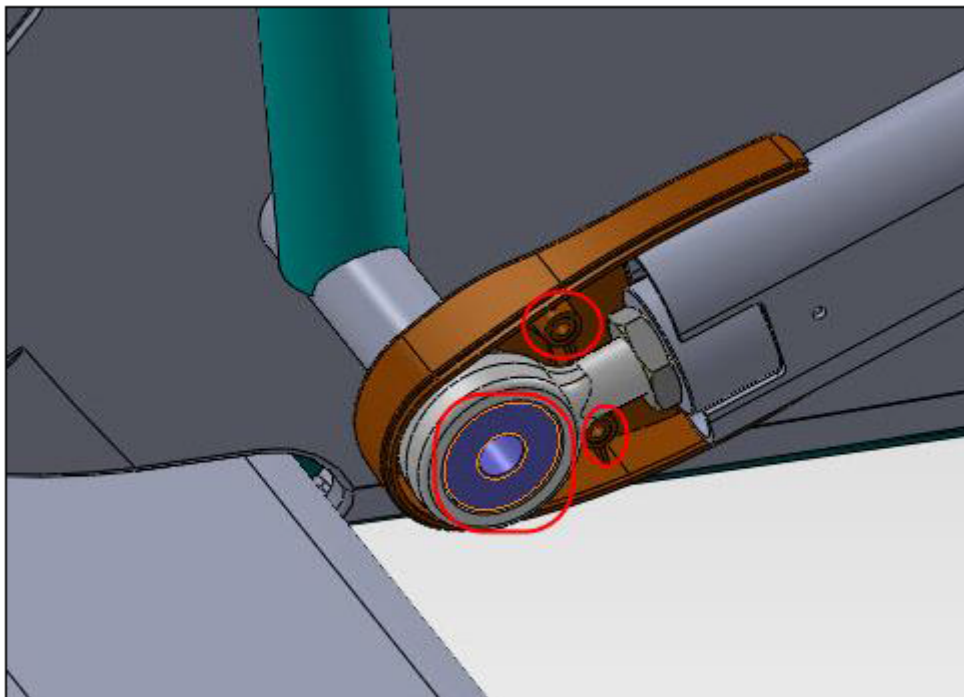
Figure B

2. Remove cap, bolt and screws to take off the Lower handlebar (Figure B)

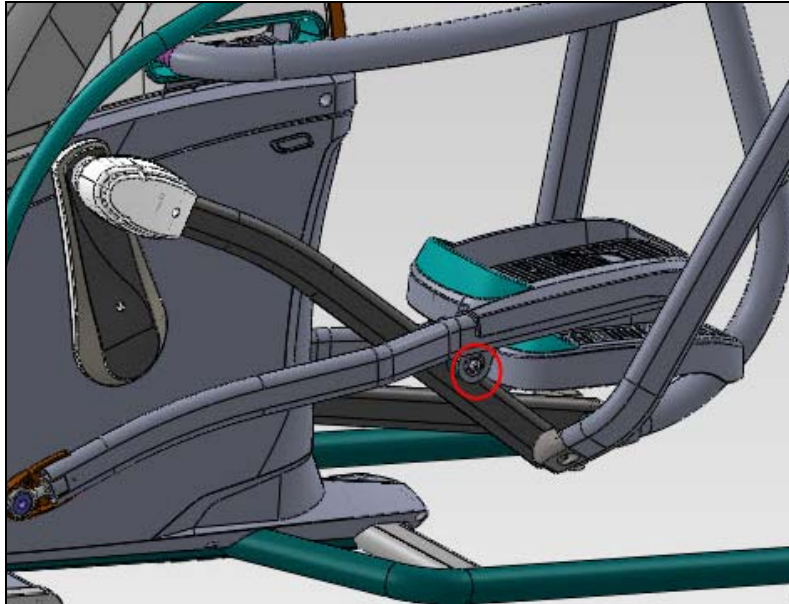
Figure A

1. Remove the following—lower handlebar (see section 4.4).
2. Remove the bolt shown in Fig A, remove the pedal arm.

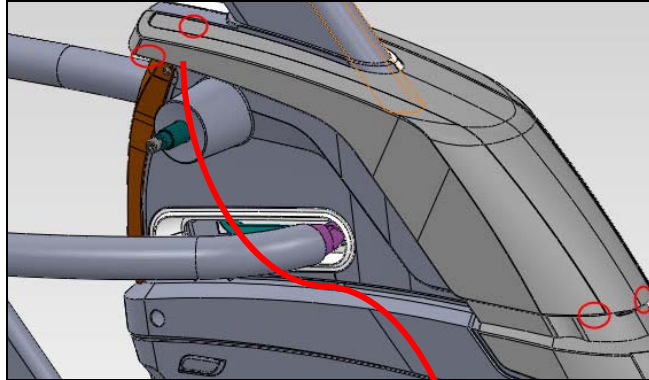
Figure A

1. Remove the 4 screws which fix the front cover. 2 in front and 2 in rear.(Figure A&B)

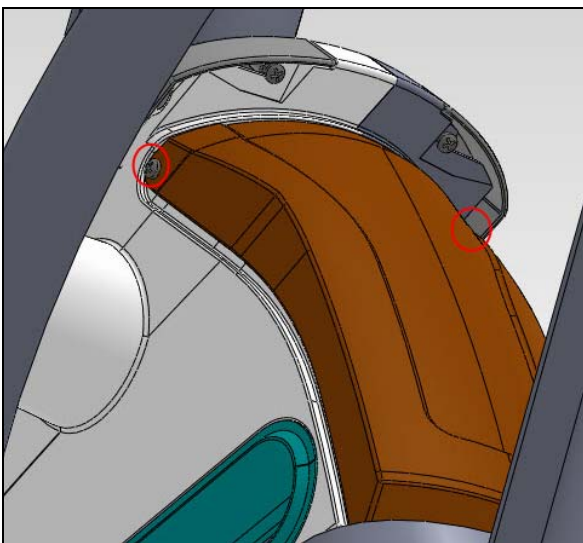
Figure C

2. Remove the 2 screws of the two side of rear cover to remove it (Figure C)
3. After removing the side cover you will see the console mast. (Figure D)

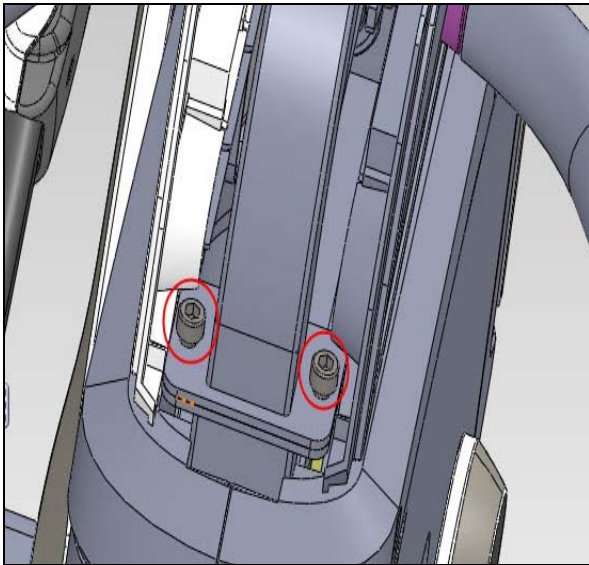
Figure A

1. Remove the following:
 - console (section 4.1)
 - console mast covers (section 4.6)
2. Remove the 4 bolts in front and rear. (Figure A&B)

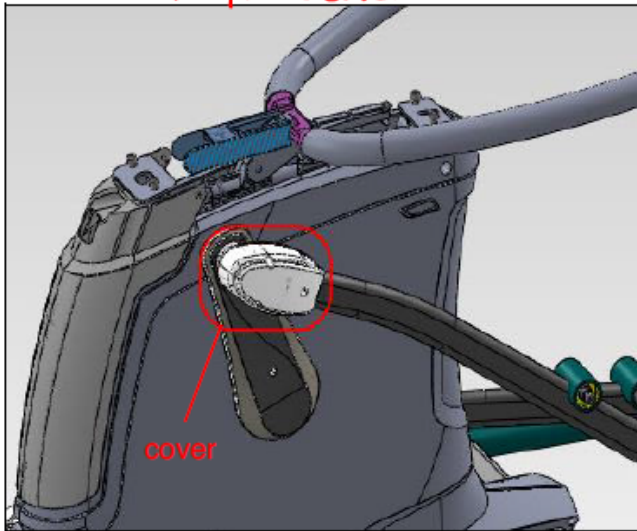
Figure A

1. Remove the pedal arm (see section 4.5)
2. Remove the plastic cover (Figure A), then remove the link arm bolt (Figure B).

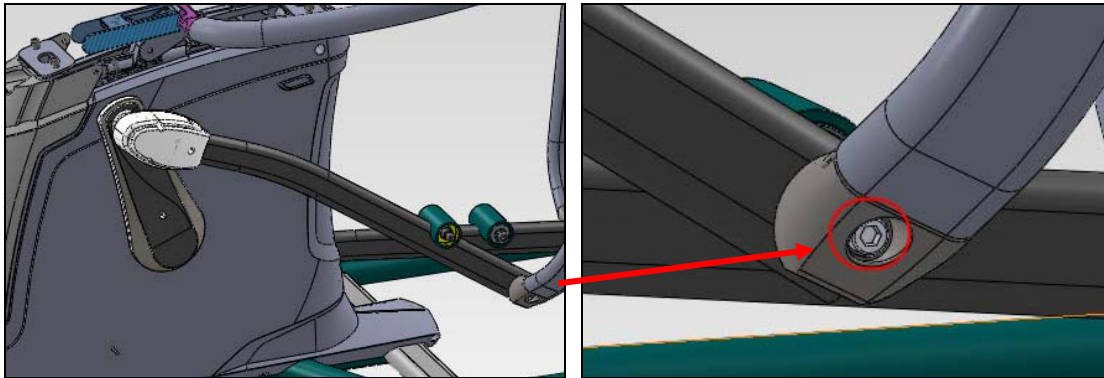
Figure C&D

3. Remove the bolt which fix the link arm and connected tube. (Figure C&D) Then remove the link arm.

Notes: torque for the link arm bolt is 800kgf.cm.

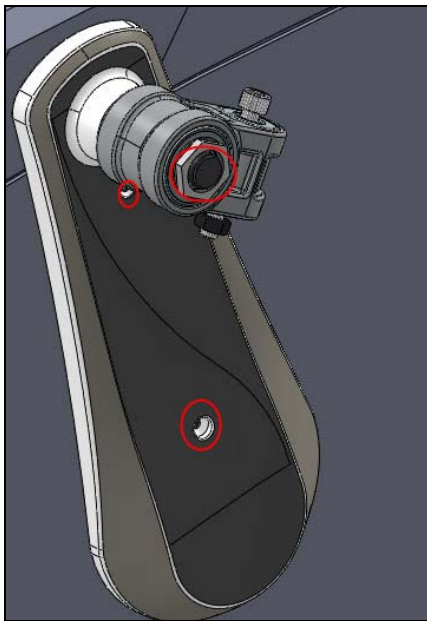
Figure A

1. Remove the link arm(see section4.8)
2. After remove the link arm, you can see the crank. Remove the nut and screws to remove the plastic cover of the crank. (Figure A)
3. After remove the cover, remove the crank arm bolt to remove the crank, a two jaw puller might be needed. (Figure B)

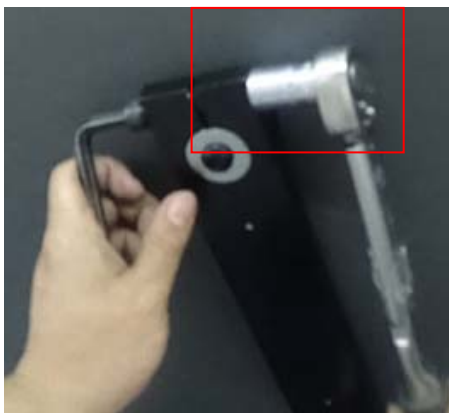
Figure C

4. The torque on crank bolts must be 800kgf.cm (Figure C & Figure D)

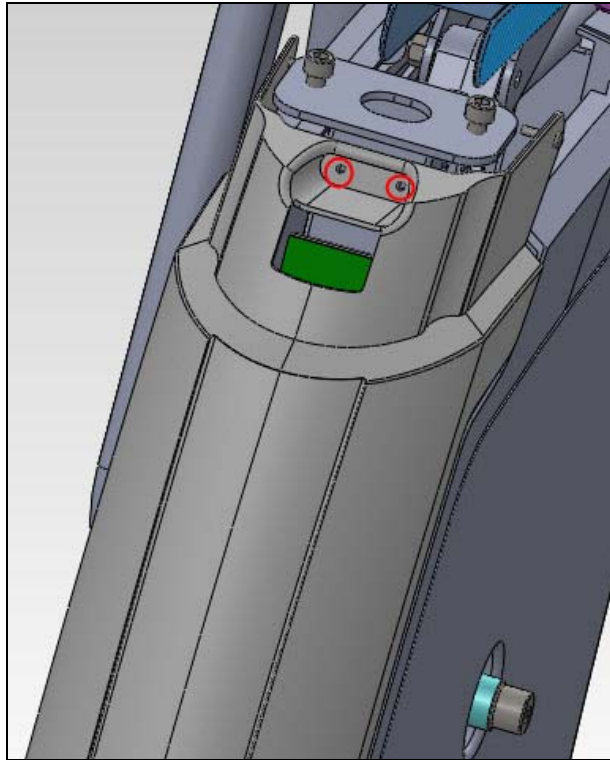
Figure A

1. Remove the console mast covers(section4.6).
2. Remove the two screws to take off the front cover. (Figure A)
3. Reverse steps to replace front cover.

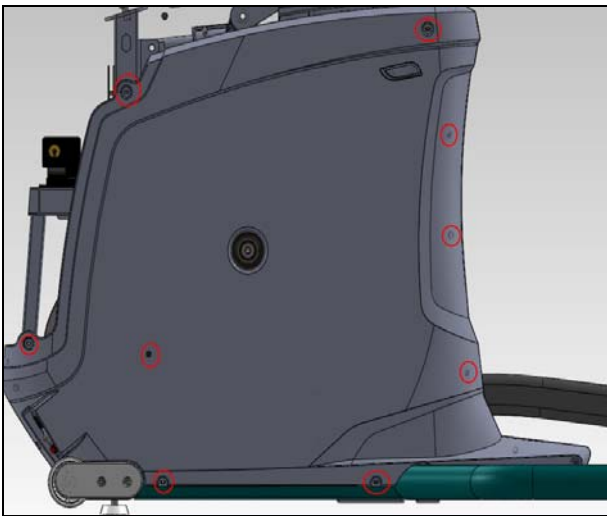
Figure A

1. Remove the following:
 - console mast covers (see section4.6)
 - Front cover (see section4.10)
 - crank arms (see section4.9)
2. Remove the 9 screws which fix the side cover.
3. Remove the 2 screws as Fig B.
4. Reverse steps to install side cover.

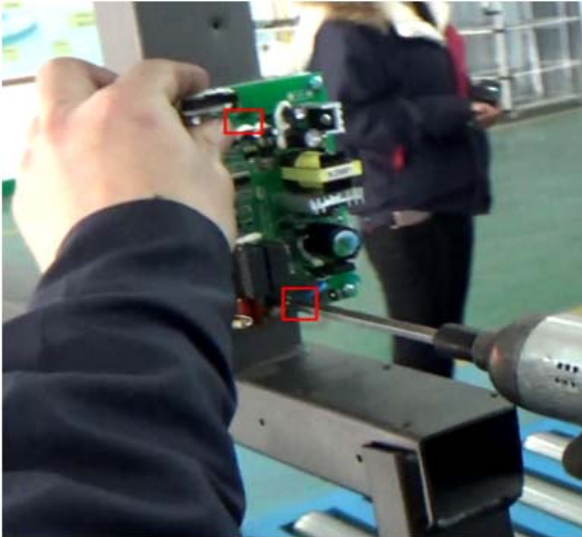
Figure A

1. Remove the following:
 - console (section4.1)
 - console mast covers (section4.6)
2. Remove the 2 screws to replace LCB. (Fig A)
3. Remove the 4 screws to replace the ECB motor (Fig B).

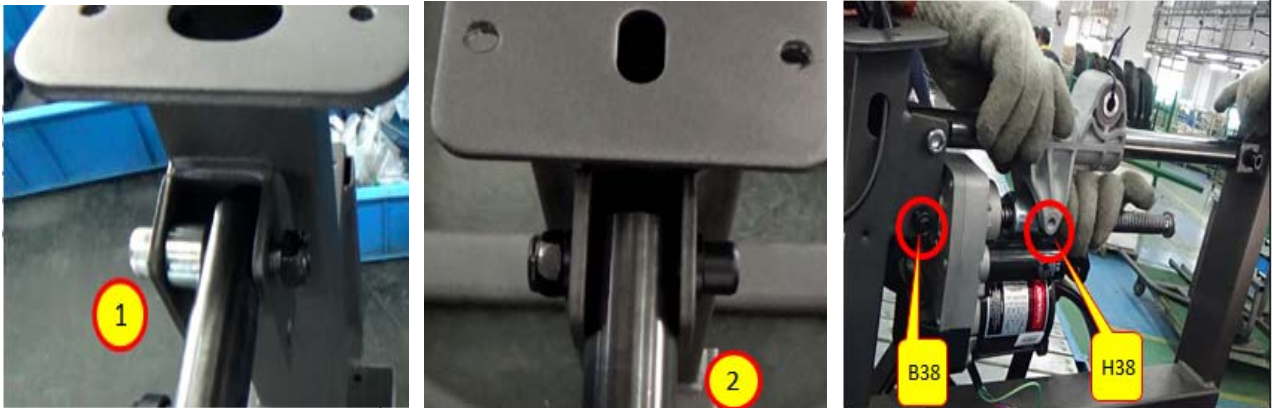
Figure A & B & C

1. Remove the following:
 - console (section4.1)
 - console mast covers (section4.6)
2. Remove 4 bolts, except H38, the torque of other bolts should be 500kgf.cm, Fig A&B &C.
